# Filter Debris Analysis

Machine Condition: **MARGINAL** #1 Gas Turbine

**FILTER DEBRIS ANALYSIS**

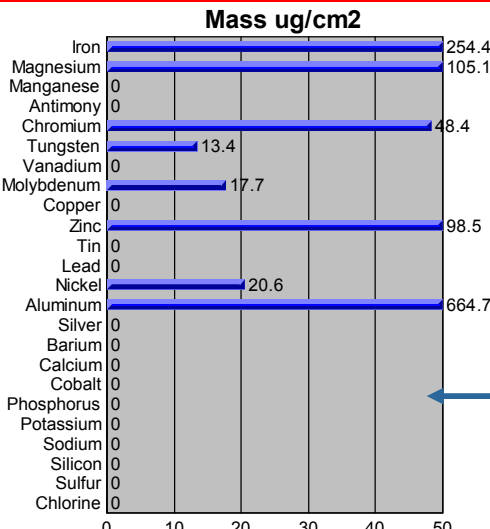
**Mass ug/cm2**

**Observations / Recommendations:**  
 The current analysis detected an abnormal wear progression. Please inspect and repair immediately. Several elements are significantly over their recommended limits. In addition, the ferrous counts on the Metalscan exceed their limits. The primary elements detected are aluminum and iron. It is likely that the wear debris may be due to failure causing damage to the aluminum housing.

Iron 254.4  
 Magnesium 105.1  
 Manganese 0  
 Antimony 0  
 Chromium 48.4  
 Tungsten 13.4  
 Vanadium 0  
 Molybdenum 17.7  
 Copper 0  
 Zinc 98.5  
 Tin 0  
 Lead 0  
 Nickel 20.6  
 Aluminum 664.7  
 Silver 0  
 Barium 0  
 Calcium 0  
 Cobalt 0  
 Phosphorus 0  
 Potassium 0  
 Sodium 0  
 Silicon 0  
 Sulfur 0  
 Chlorine 0
